# A Neighborhood Walk in Fairview

*Anchorage Design Week  
February 25, 2024*

Mary Dean Broussard  
AARP AK  
Age-Friendly Anchorage

# The Route for the Fairview Neighborhood Walk

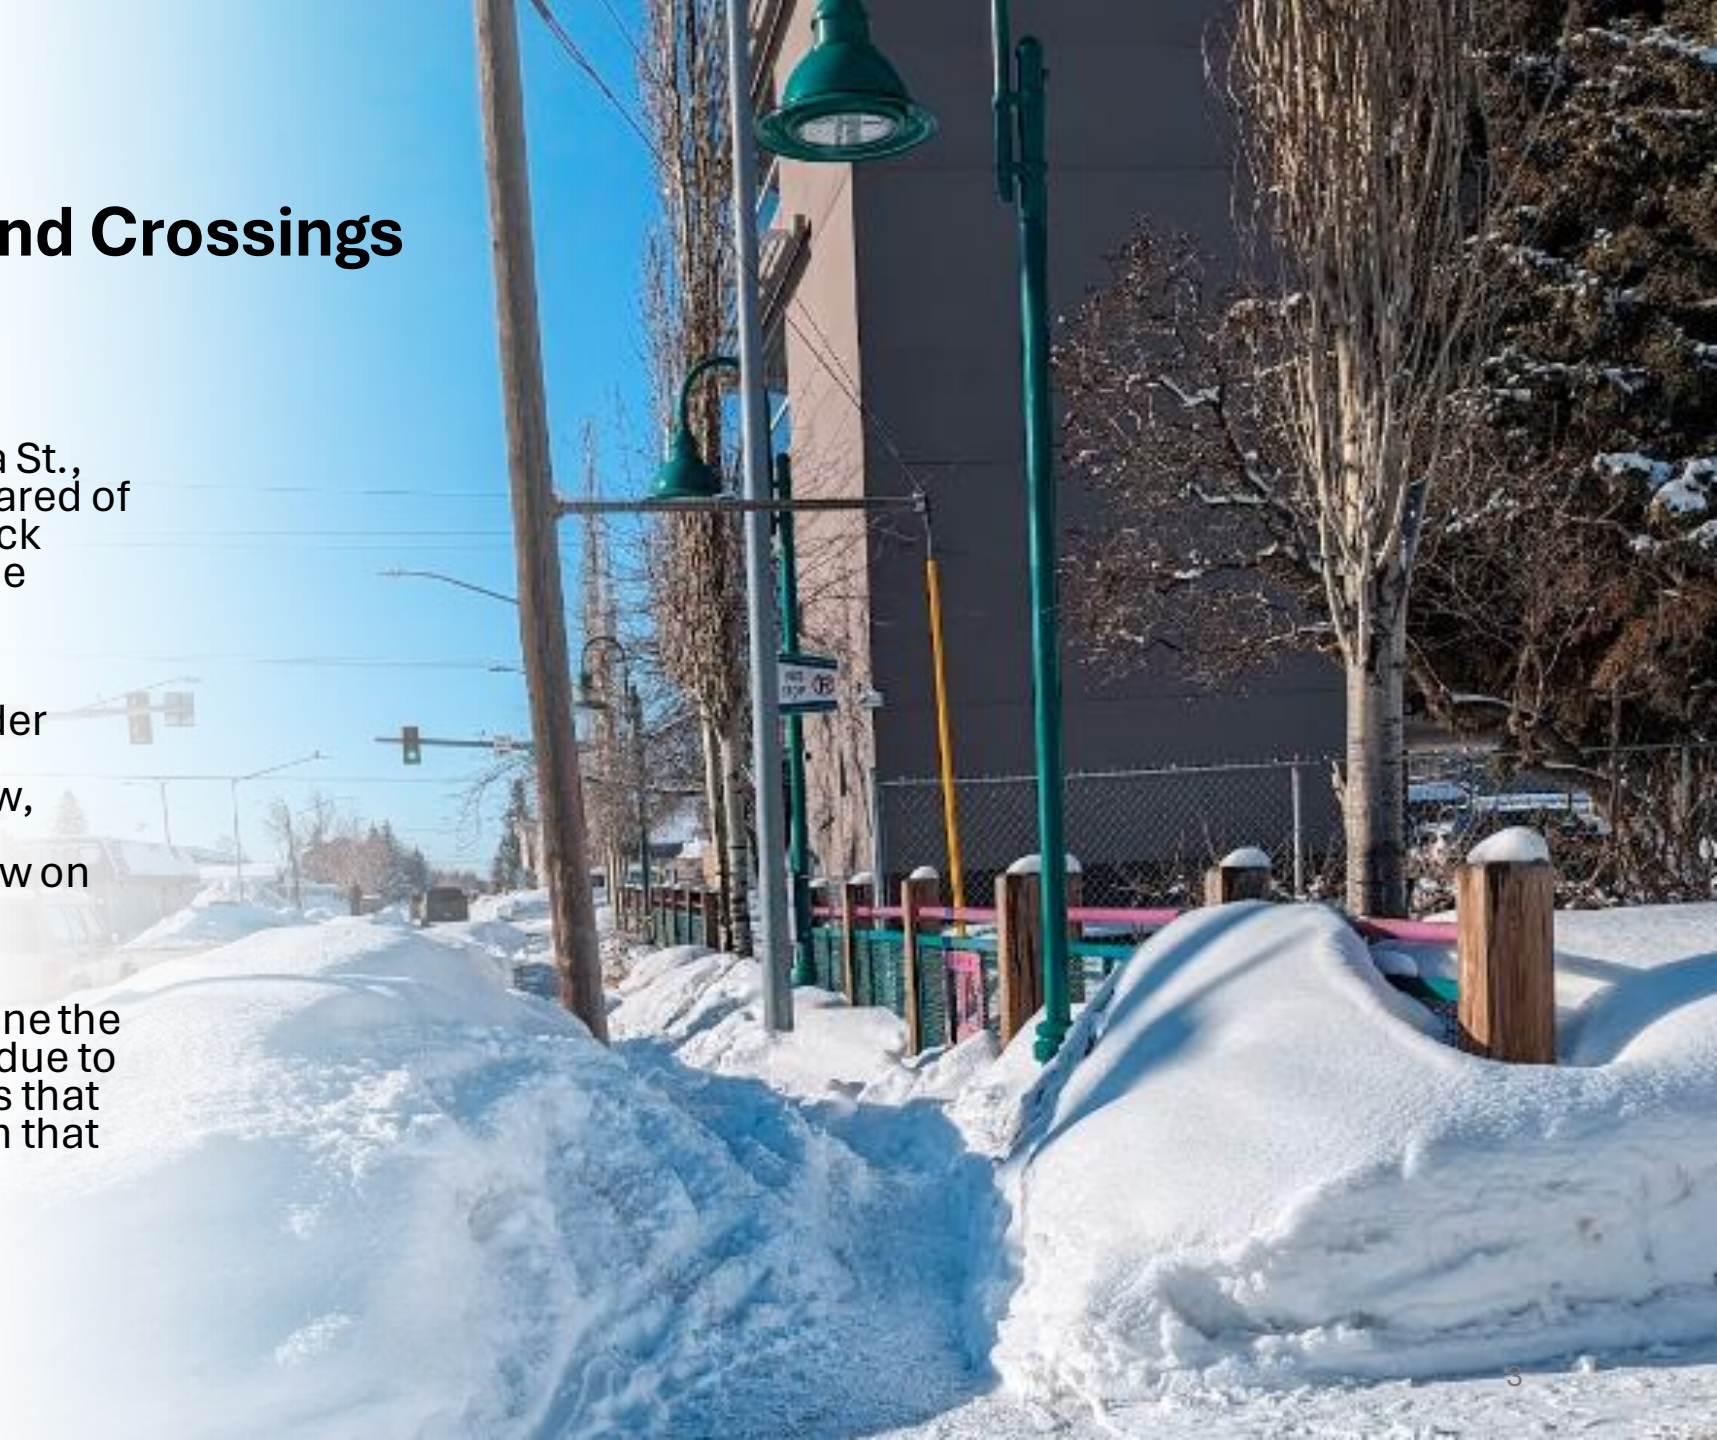
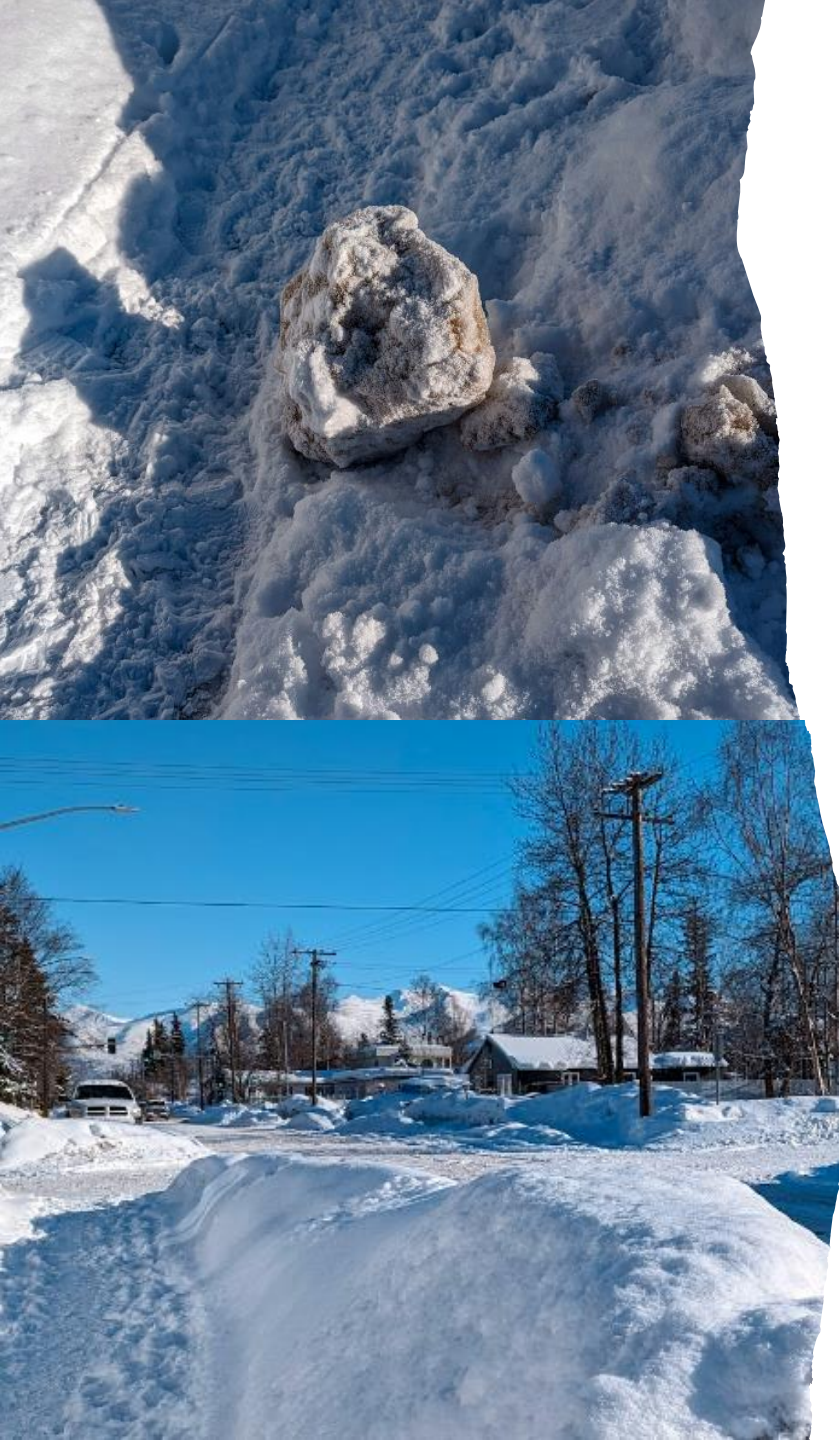
- Between the church and Ingra St., the sidewalk was partially cleared of snow however there was a thick layer of bumpy ice covering the sidewalk.
- The sidewalks on the remainder of 13th Ave. were sometimes partially cleared of some snow, however there was always a hardened layer of ice and snow on all visible sidewalks.
- It was not possible to determine the width of any of the sidewalks due to the snow cover. The sidewalks that were shoveled only had a path that was less than two feet wide. Shoveling was very sporadic.

There is no separation between E. 13<sup>th</sup> St and the sidewalks. The current sidewalk condition for the entire stretch we covered was poor to extremely poor given the accumulation of snow and ice. At some points boulders of ice were present on the sidewalk path (top photo.)

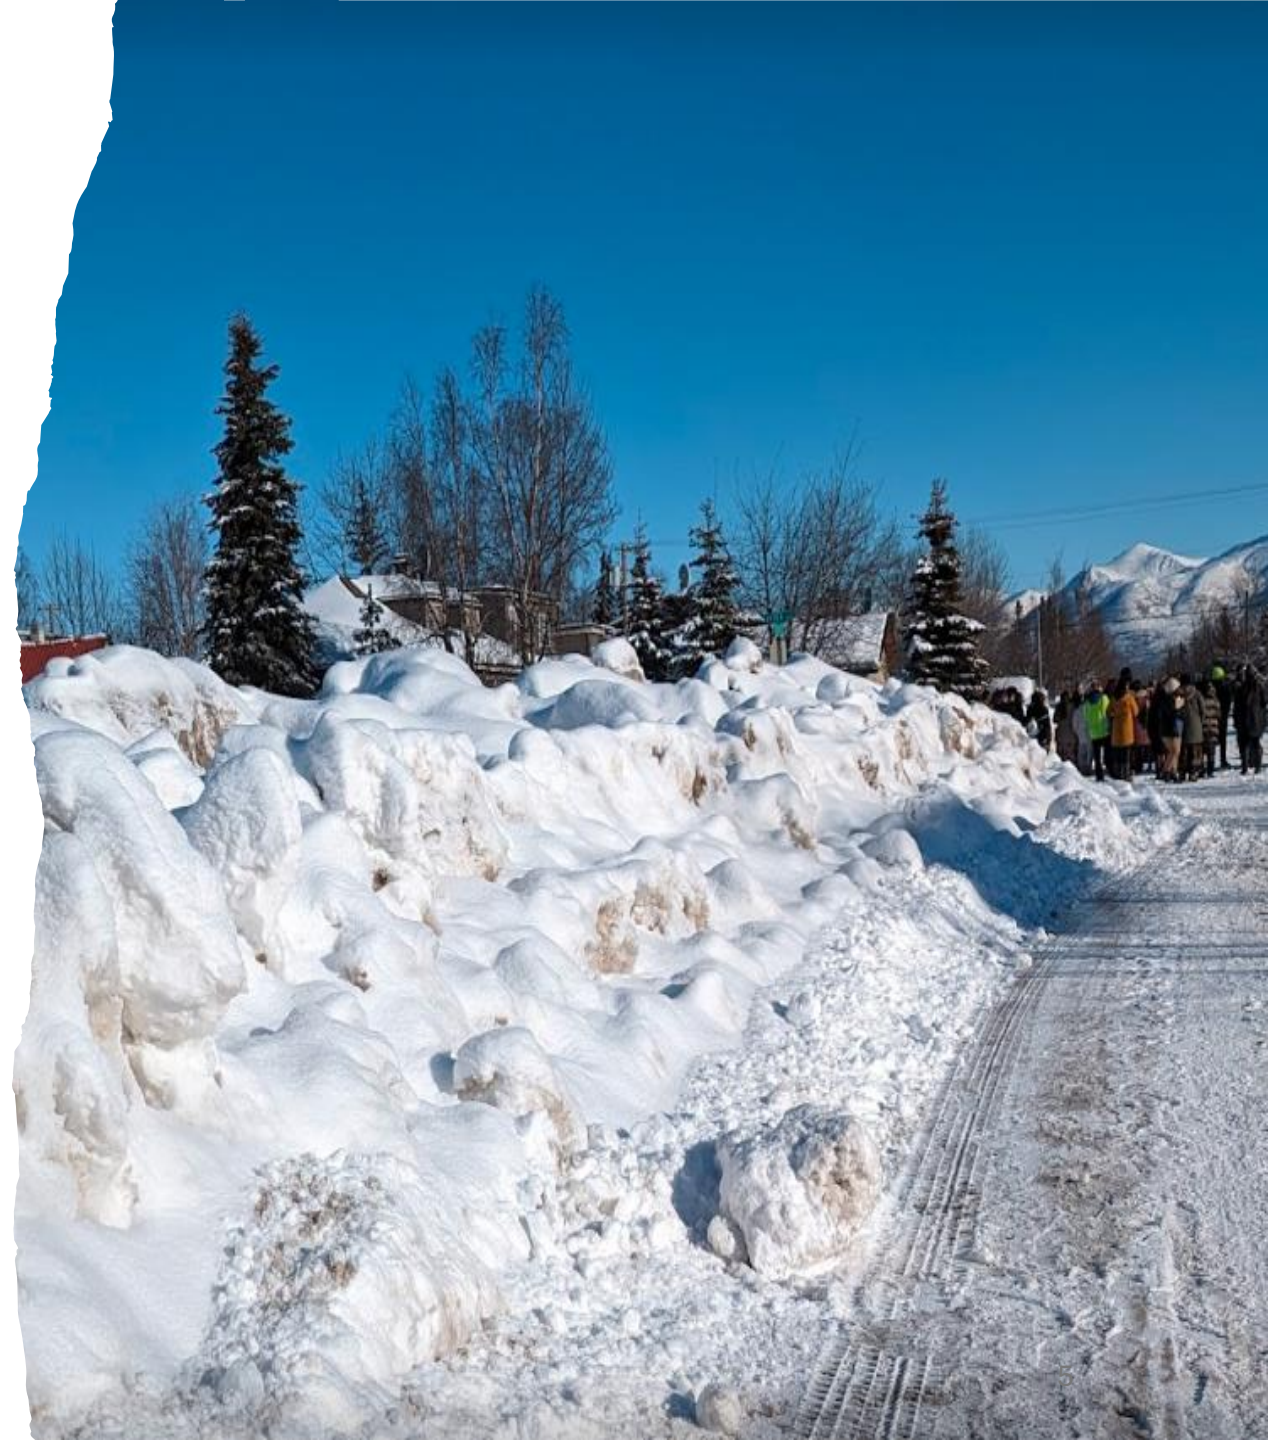
- E. 14<sup>th</sup> Ave. Sidewalks have not been cleared. Perhaps they have never been cleared since the first snowfall in Nov. 2023.
- In the Hyder St. area, the E. 14<sup>th</sup> Ave sidewalk area was covered with a large pile of snow. It looked like it was used as an area to dump plowed snow (see photo.)
- In the current conditions (accumulated snow and ice) it is impossible to determine whether there are:
  - Curb cut ramps to assist people crossing using wheelchairs, walkers or strollers.
  - Tactile ground surfaces when a sidewalk is ending (such as at an intersection.
  - Any separation or barrier from the street
  - Although the sidewalks are not currently visible it is likely that there are many interruptions for driveways.

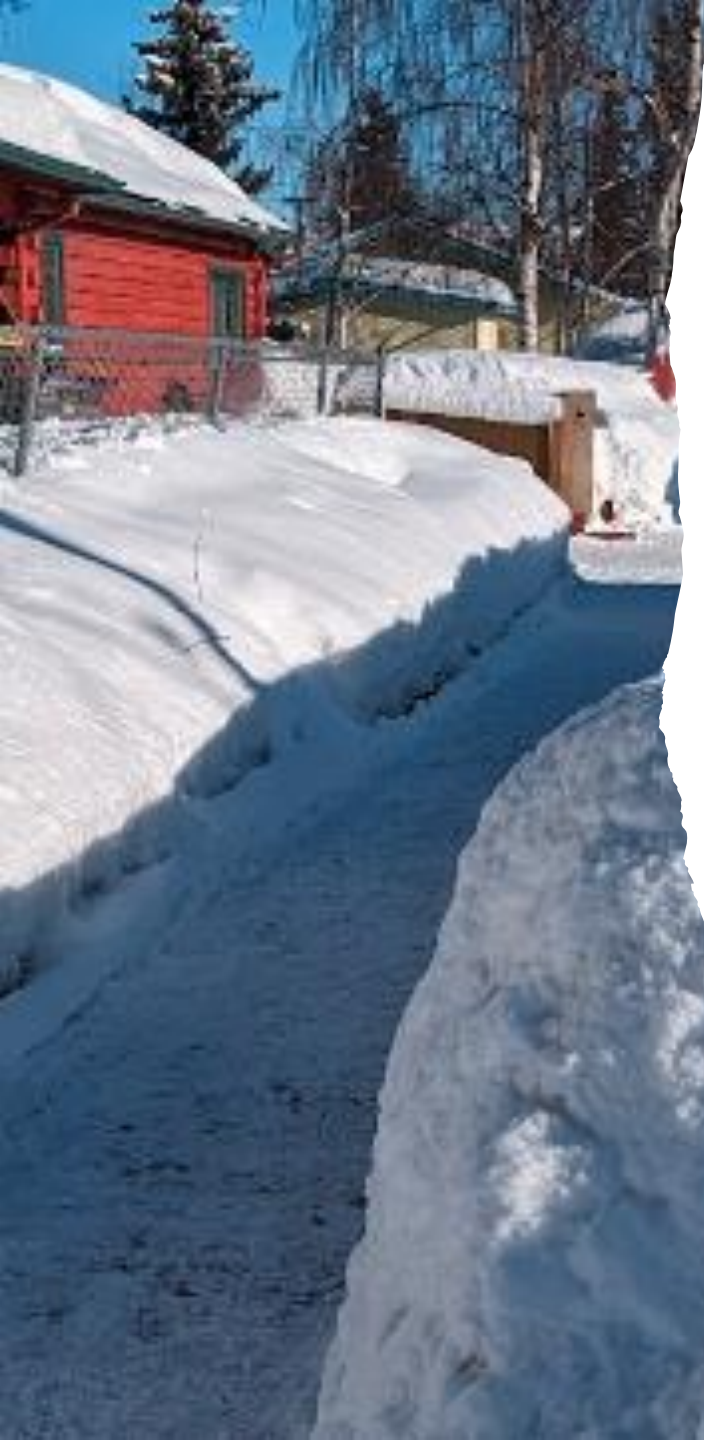
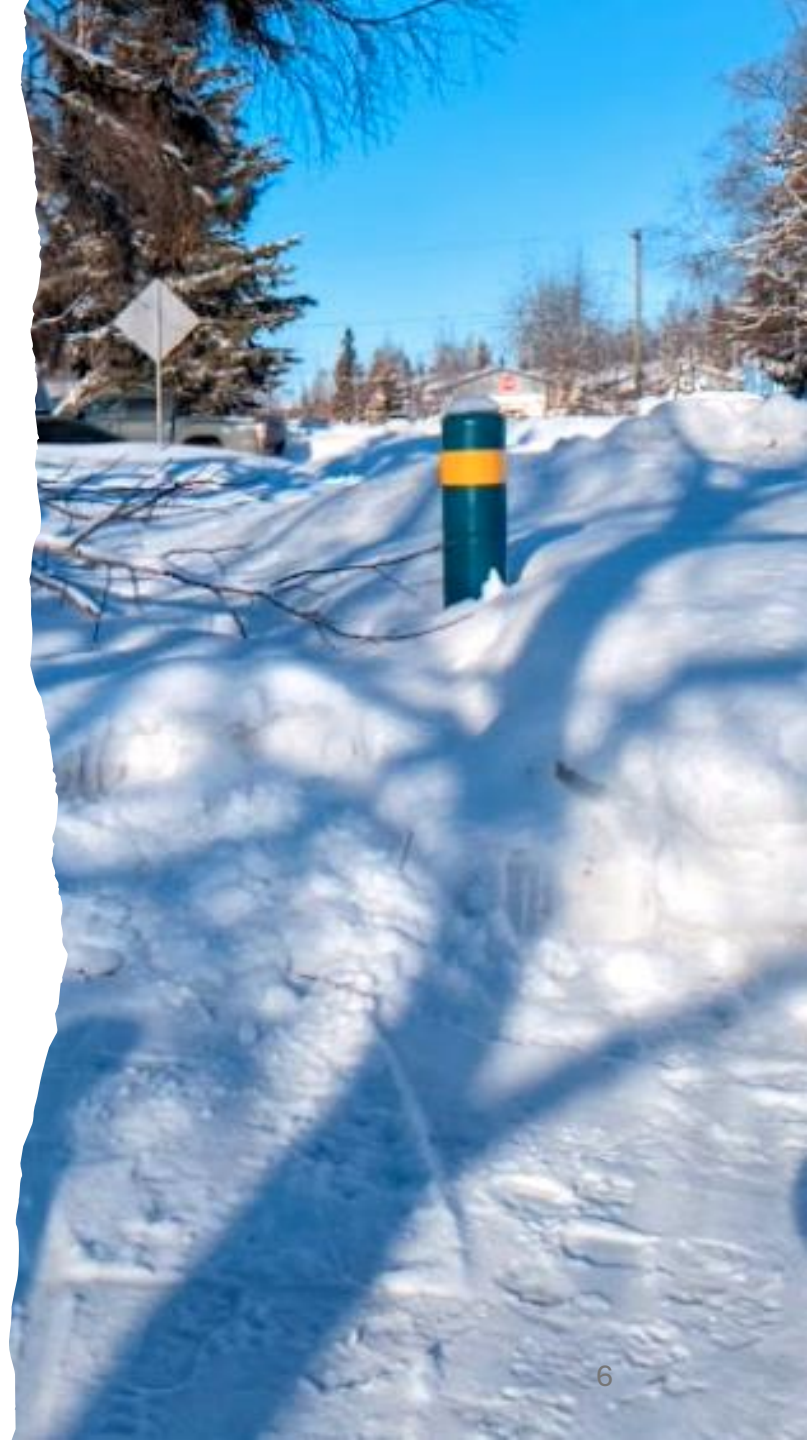
There was snow and ice accumulation on Juneau St. But about half of the sidewalks had been cleared recently as shown in the photo on the bottom left.

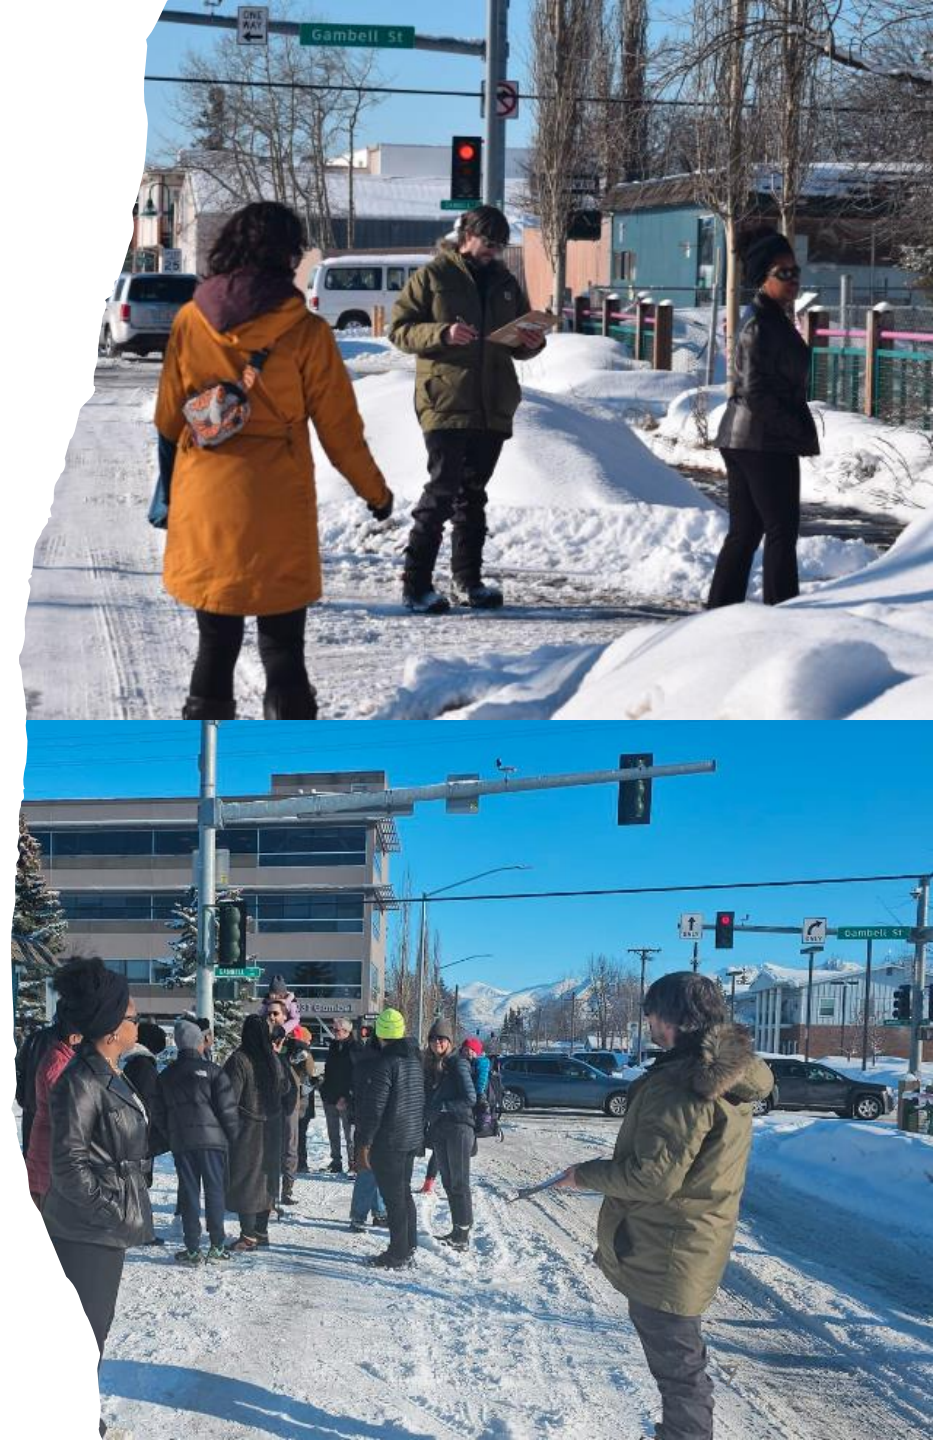
- Traffic lights seen are at the intersection of E. 13<sup>th</sup> Ave. and Ingra St. and E. 13<sup>th</sup> Ave. and Gambell St. are clearly visible to drivers and pedestrians. Each has a crosswalk and a push button crosswalk signal. The crosswalk are only partially visible due to snow and ice accumulation.
- There is no audible component for the crosswalk.
- There is no signage alerting drivers to pedestrians crossing at the intersection of E. 13<sup>th</sup> Ave. and either Ingra St. or Gambell St. Nor is there signage alerting drivers to pedestrians crossing at the intersection of E.14th Ave. And Ingra St. And Gambell St.
- Due to snow and ice accumulation, it is not clear if there is a pedestrian crossing at the intersection of E. 13<sup>th</sup> Ave and Hyder St.
- There is no dedicated bike lane in any of the area covered in the walk.

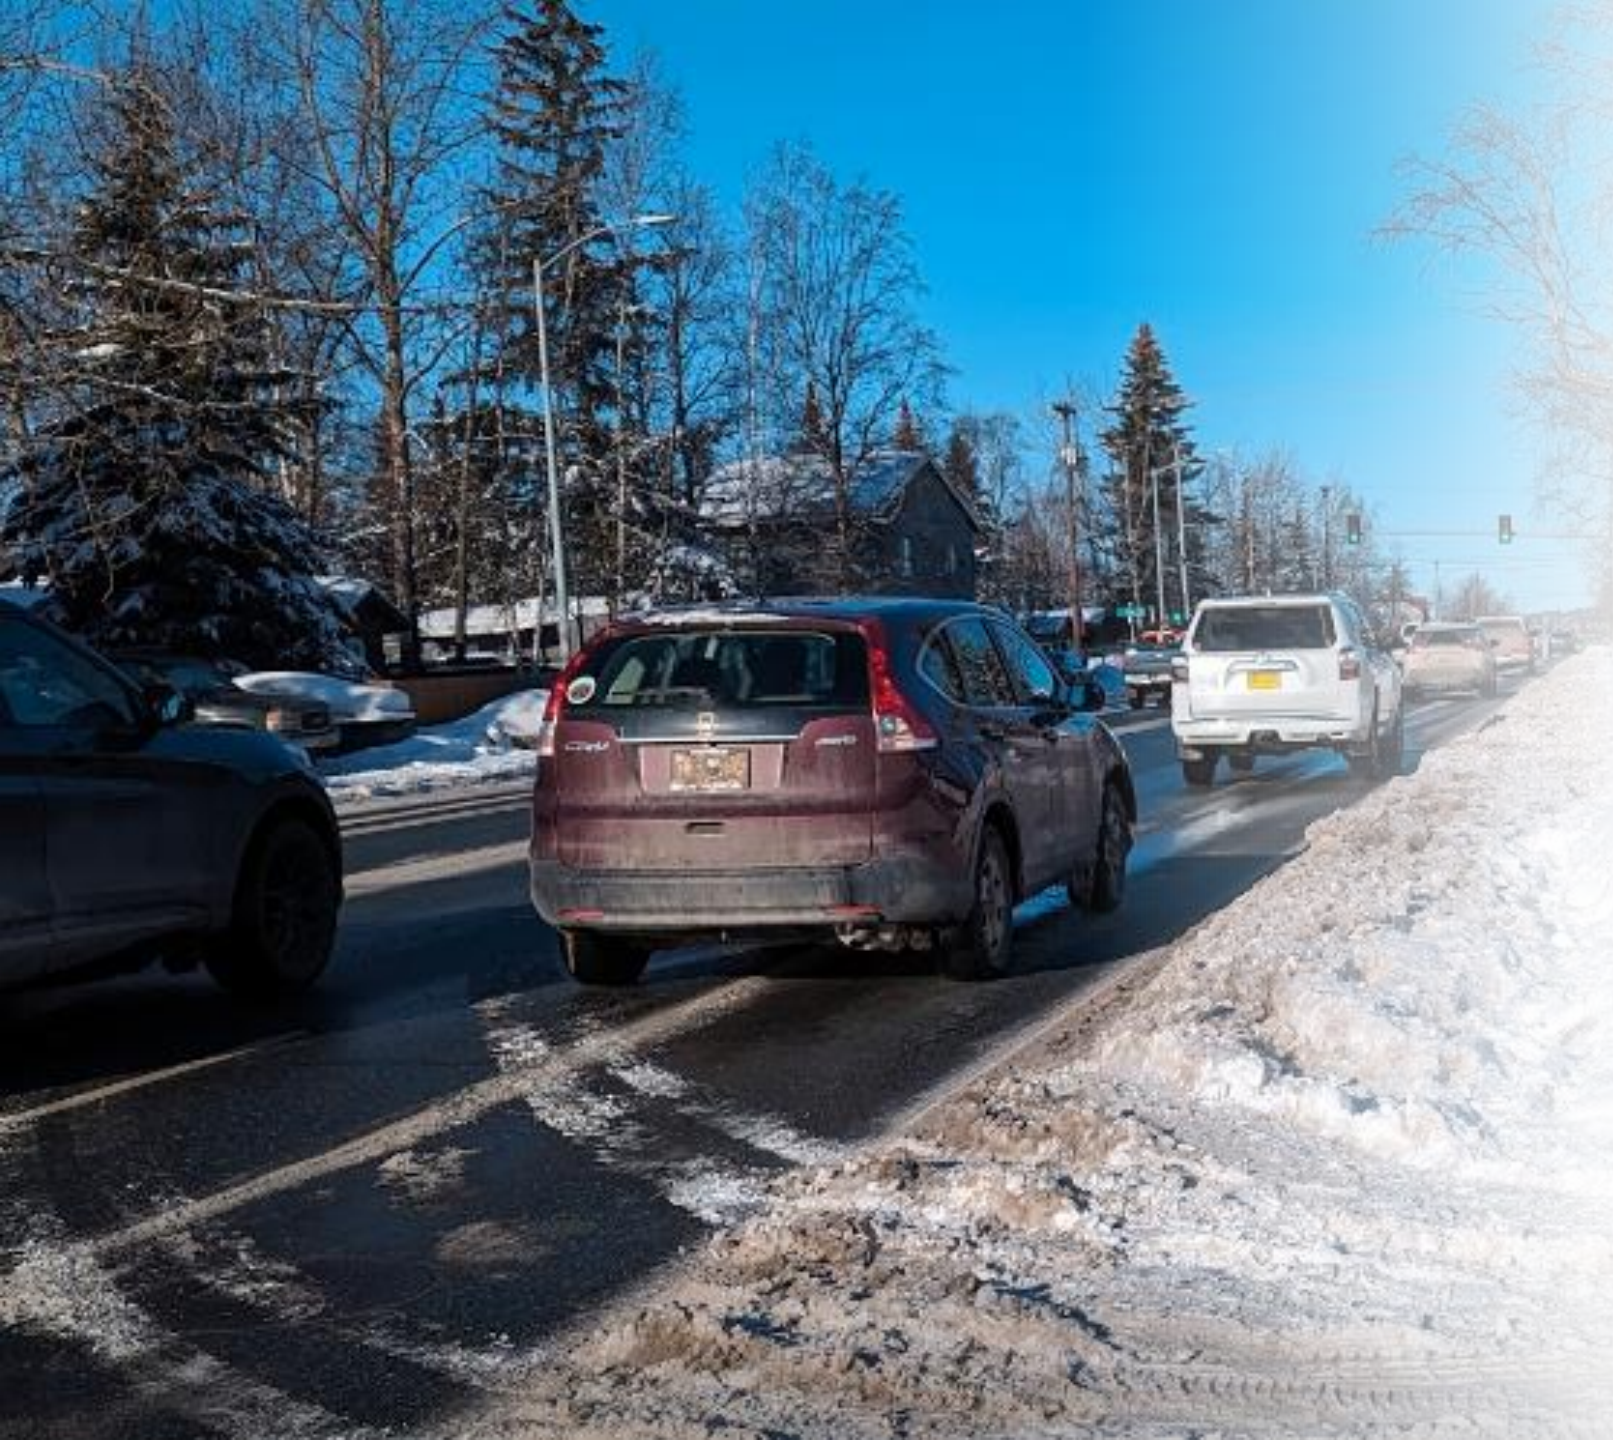
*Ingra St. & E. 14th Ave.*

Both Ingra and Gambell St. have sidewalks however there was no sidewalk visible on the day of our walk. We were not comfortable walking on the sidewalks along Gambell or Ingra Streets. Snow from the roadway was recently plowed onto the sidewalks making a narrow and unsafe walking surface. Gambell Street, like Hyder Street, also has utility poles in the middle of the sidewalks. Rather than walking on Gambell St. sidewalks, our group instead walked in the maintained Carr's parking lot

The speed limit is 35 MPH. The fastest vehicle we recorded during our walk on a quiet Sunday afternoon was travelling 40 MPH. One of the walkers reported that "even when vehicles are going the speed limit it is uncomfortable to walk directly next to them and it still feels too fast."
